INSPECTION REPORT

4823 Walnut Grove Street, Harrisburg, North Carolina 28075

Aug 2, 2024

Matthew Gurley

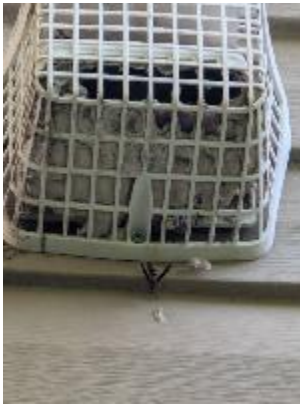
Laundry Room / Mudroom

Dryer vent appears to be clogged with nest at exterior exit.

A clogged dryer vent is unsafe and could cause a house fire.

Recommend cleaning dryer vent prior to use.

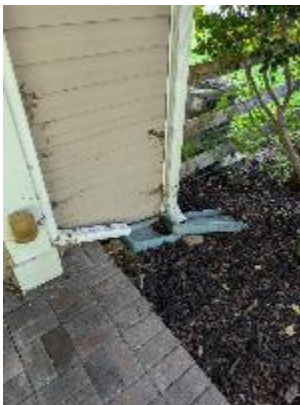
Exterior: Ground View

Extensions are missing

Water flow is not contained and may drain near foundation increasing the risk of flooding

Extension discharges to an obstacle

The obstacle prevents rain water from discharging away from the foundation increasing the risk of moisture intrusion

Install downspout extensions reaching 5-6 feet from the building

Replace the extension to be away from the obstacle

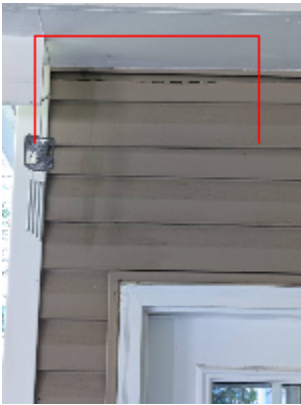
Exterior: Ground View

Missing

Without siding, protection from elements is lacking

Replace the missing section of siding

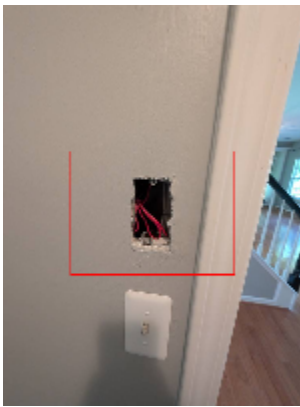
Attic, Laundry Room / Mudroom

Has open wires

Exposed energized wiring can be hazardous to touch

Have repaired by a licensed electrician

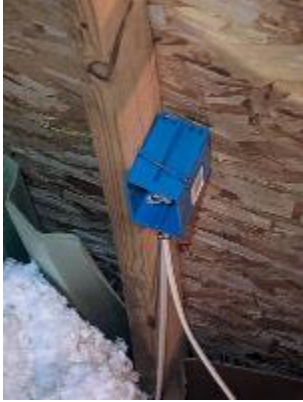
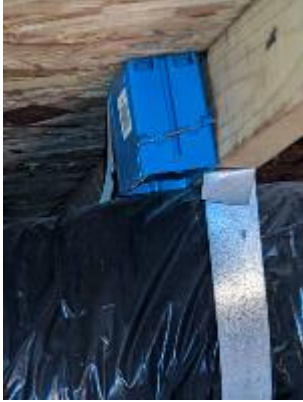
Cover plate is missing

Without a cover plate, electrical shock may result if touched

Install a cover

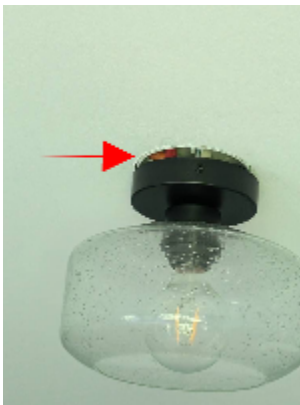
Hallway and Stairs, Bedroom

Loose and/or not affixed to the ceiling or wall

A loose light fixture may dislodge from the ceiling

Secure to the wall or ceiling

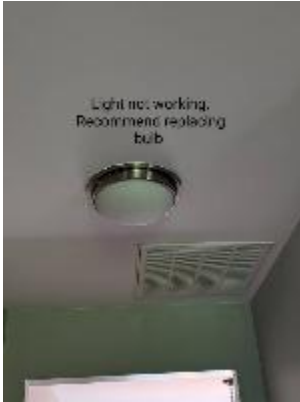
Bulb is burned out

Replace the bulb

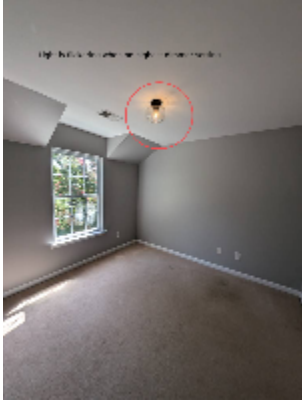
Bulb is flickering

If the flickering is related to loose wiring, it may arc and ignite

A flickering bulb may indicate potential loose wiring

Ensure the wires are securely connected with a proper connector. If the bulb is still flickering, have repaired by a qualified electrician.

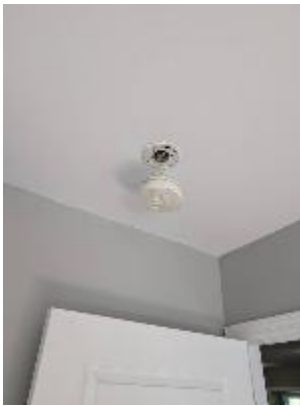
Family Room, Bedroom

Smoke detector hanging from wires

Wires exposed, could come loose and have exposed hot wires. Not secured properly.

Ensure that smoke detector is wired properly and secured to ceiling by qualified person.

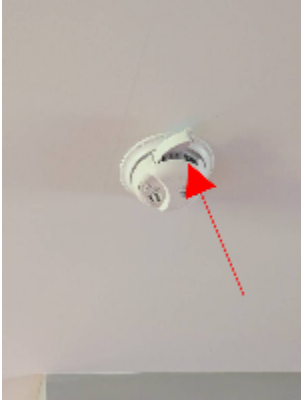
Battery has been removed from smoke detector.

If the power goes out, the smoke detector will not work properly and detect if there is smoke or fire in the home.

Recommend replacing battery in smoke detector.

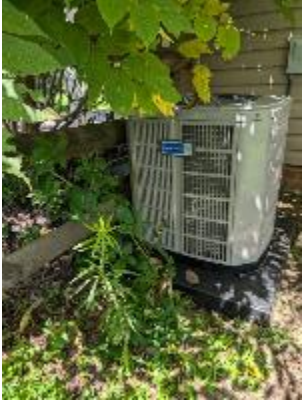
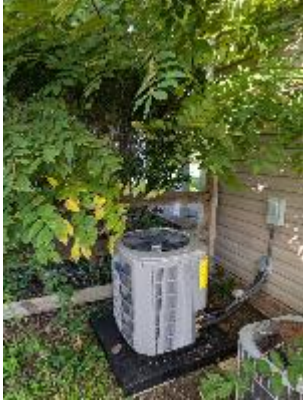
Condenser airflow is blocked by vegetation

An air conditioner is engineered to remove the heat by having a designed amount of air flow over the condensing coil. If less air flows over the coil, less heat is removed. That means the whole cycle warms up a bit, and your AC works harder to keep your home cool.

Cut back the vegetation

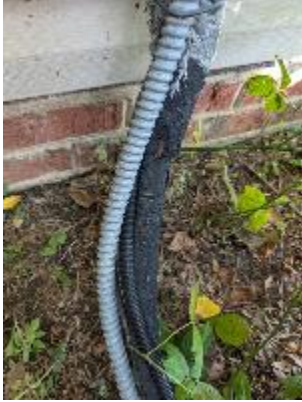
Insulation is damaged

Without proper insulation, the warmer air may create condensation on the suction line, which could damage the surrounding area and/or create a slipping hazard. In addition, by warming the refrigerant, operating efficiency is reduced.

Replace the insulation with 3/4 to 1 inch vapor-proof insulation

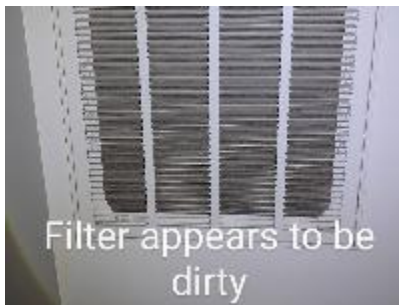
Hallway and Stairs

Air filter on return vent downstairs appears to be dirty

A dirty air filter can cause cooling system to not function properly.

Recommend further evaluation and/or repair by a qualified person.

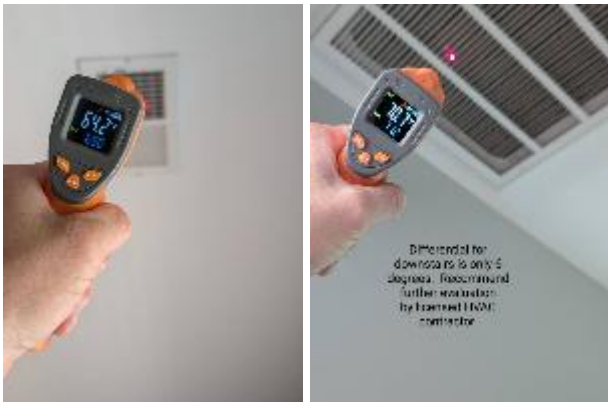
Hallway and Stairs

Temperature differential between supply and return is 6 degrees.

Air conditioning unit is not cooling efficiently.

Recommend further evaluation and/or repair by Licensed HVAC contractor.

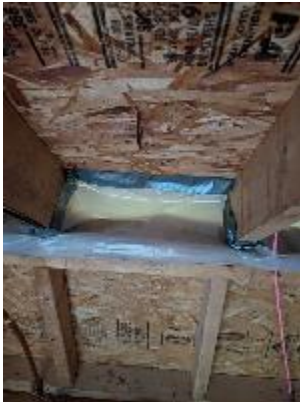
Blocked

Without proper venting, moisture will build up in the attic, potentially causing mold growth. The excessive heat may also damage roof decking and roof shingles as well as cause cooling equipment to work harder.

Clear the blocked vent

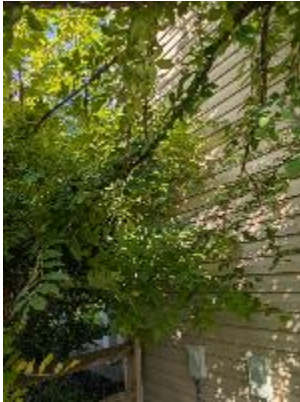
Exterior: Ground View

Vegetation is growing against the home.

Vegetation growing against home can cause damage to siding; allowing moisture and/or pest intrusion.

Recommend trimming back vegetation by a qualified person.

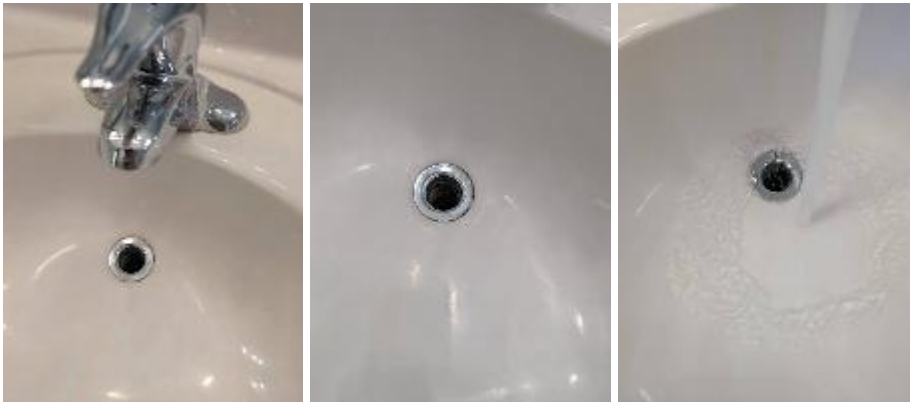
Drain stop is missing

Replace the drain stop

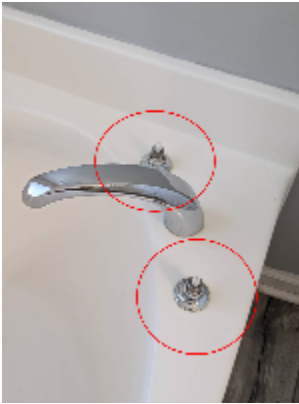
Faucet handles do not operate

Repair the handle valve or replace the entire faucet assembly

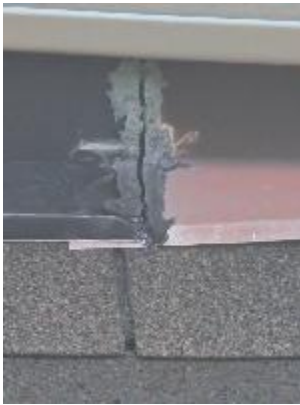
Exterior: Roof View

Caulk/sealant is deteriorating on headwall flashing on back of home.

Deterioration of caulk/sealant could allow water intrusion.

Recommend further evaluation and/or repair by qualified roofing contractor.

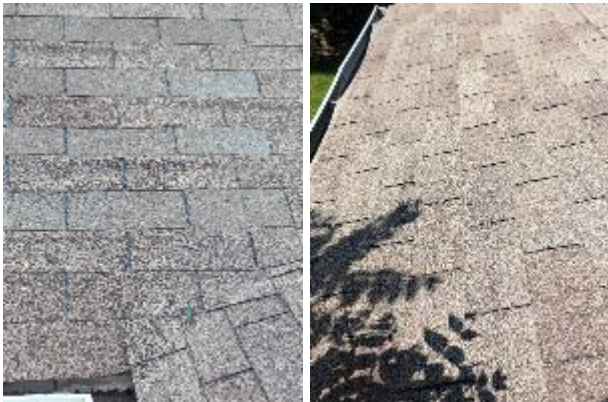
Exterior: Roof View

Shows signs of excessive wear

The condition of the roof will further deteriorate and water could infiltrate causing interior damage

Excessive wear is a sign that the roof is nearing the end of its useful life

Budget for a new roof. In the interim, a higher level of maintenance can be expected. Recommend further evaluation and/or repair by a qualified roofing contractor.

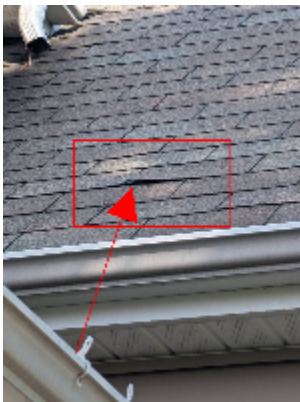
Exhibits nail popping and/or exposed nail heads

If left unattended, the roofing system will be compromised, and water could penetrate the wood causing leaks and interior damage

Nail pops can be caused by a variety of reasons. When the temperature changes, expansion, and contraction can cause the nails to pop up and lift the shingles. It may also be caused by inadequate ventilation. Other causes of nail pops can be that the shingles were not nailed tightly when the roof was installed.

Replace the popped nail with a new nail 1" higher than the existing hole. Make sure to apply roofing cement to cover the existing nail hole.

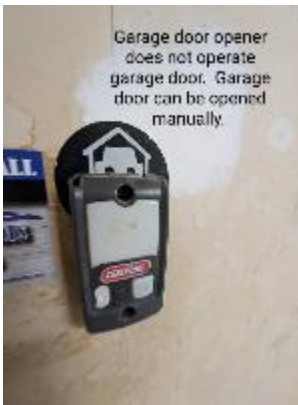
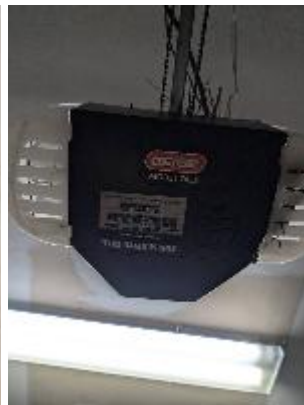
Garage

Button on the wall switch does not operate the door. Door can still be opened and closed manually.

Door cannot be opened with automatic opener switch.

Recommend further evaluation and/or repair by a qualified person.

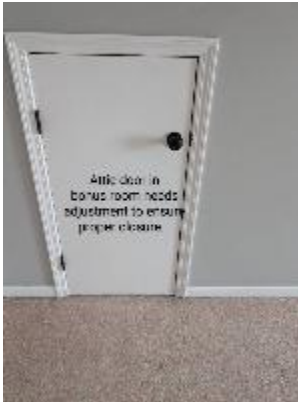
Attic door not closing properly.

Door does not close all the way which could allow unconditioned air to enter conditioned space which lessens the efficiency of heating/cooling system.

Recommend having adjusted by a qualified person so that door closes properly.

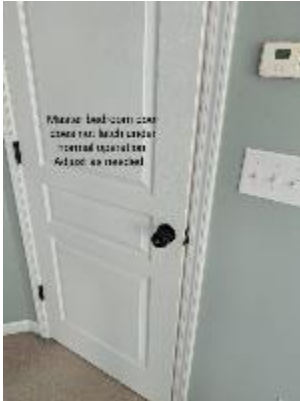
Door not closing properly.

Door does not close with normal operation.

Recommend having adjusted by a qualified person so that

door closes properly.

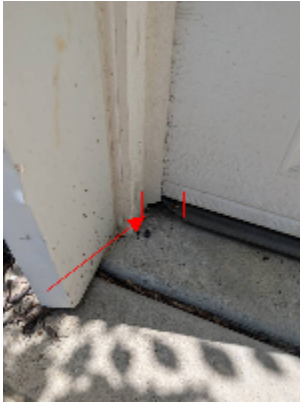
Garage

Bottom weather seal is damaged or missing

Without a weather seal, exterior air and elements could enter the garage

Replace or install new weather seal
