INSPECTION REPORT

1156 Windsor
Drive,
Kannapolis,
North Carolina
28081

Aug 21, 2024

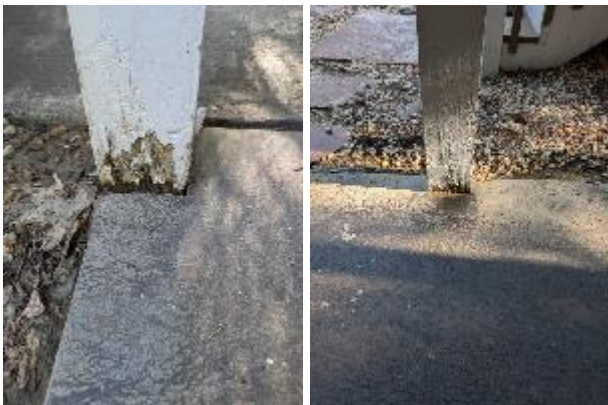
Support posts are showing wear

If not addressed, the post may dry or rot

Paint, stain and/or seal with a weatherproof product

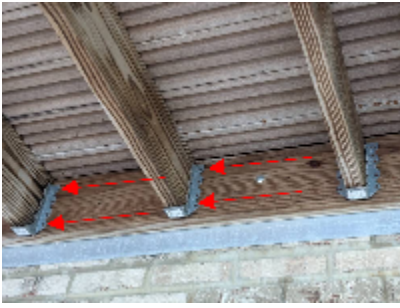
Joist Hangers are missing nails. Also, nails used are common nails, not those recommended for joist hangers.

Proper nails should be used in all holes of joist hanger for overall safety and stability.

Recommend further evaluation and/or repair by a qualified person.

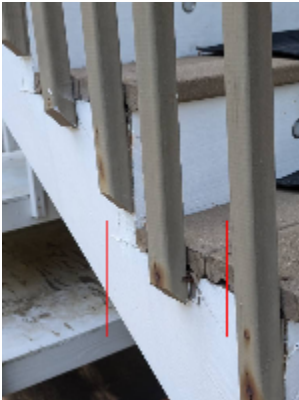
Baluster is not attached at the bottom

Baluster is not attached when could be a safety issue.

Recommend reattaching baluster by a qualified person.

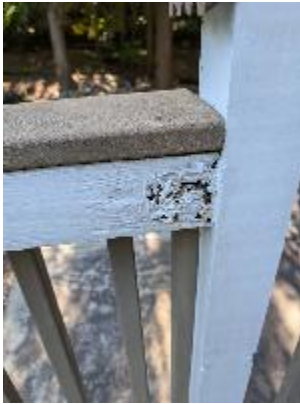
Handrail is deteriorated

The deterioration reduces the stability of the railing

Replace the damaged component

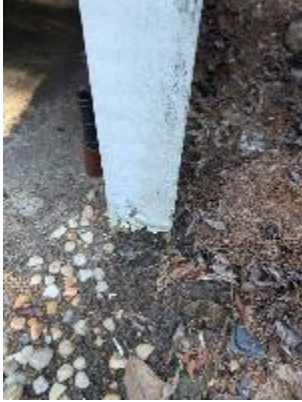
Wood is in contact with soil

The soil may cause moisture damage to the wood

Monitor for wood deterioration. Should deterioration continue have repaired or replaced.

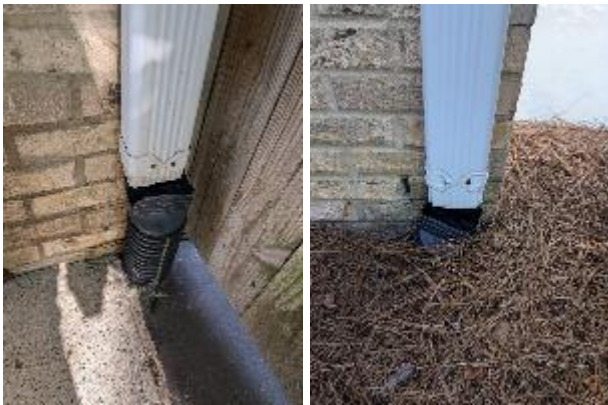
Downspout is disconnected from drain pipe.

Water could divert toward home foundation.

Recommend reconnecting downspout to drainage pipe by a qualified person.

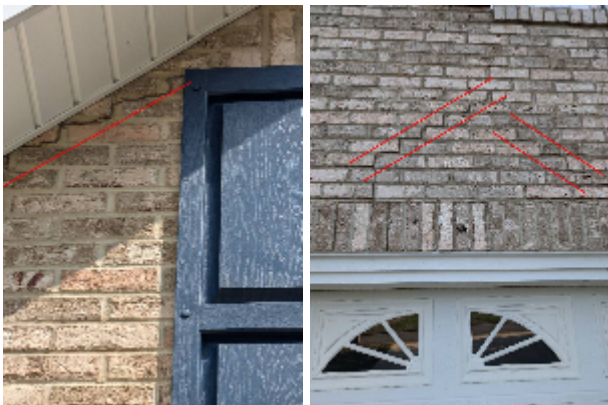
Shows evidence of previous repair

Monitor for moisture intrusion. If you see new leaks further evaluation by a qualified mason is recommended.

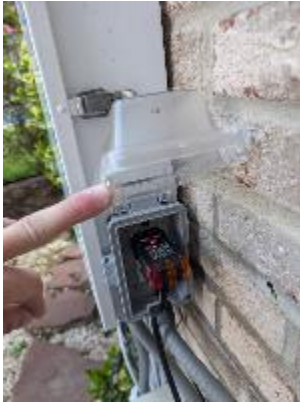
There is no power at this outlet.

Unable to use this outlet

Recommend further evaluation and/or repair by Licensed Electrical Contractor

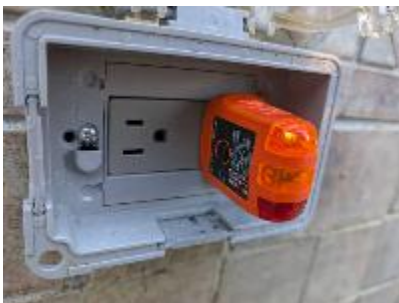
Tester shows open neutral

An open neutral outlet can cause an electrical shock through an appliance

Have repaired by a licensed electrical technician

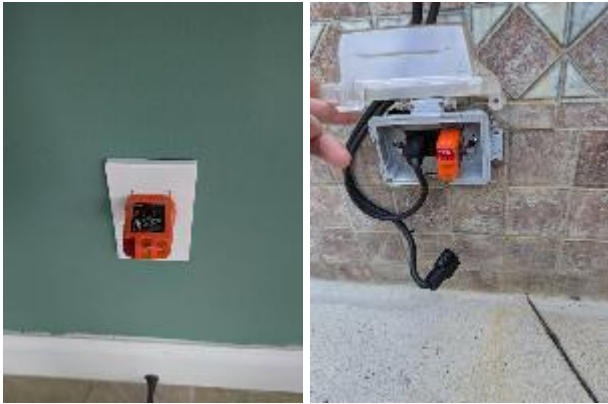
Appears to have no power

Have repaired by a licensed electrical technician

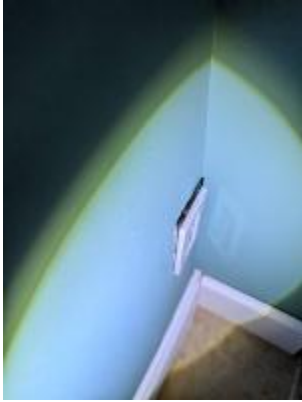
Not secured to the junction box

Without an improperly secured junction box the wiring is exposed thus lacking protection from shock or arcing

Secure the outlet to the junction box and reinstall the cover plate

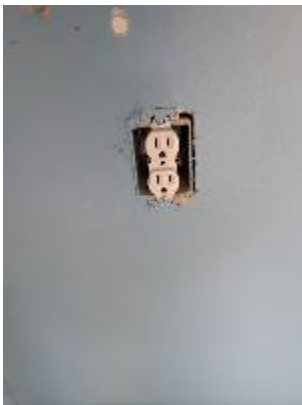
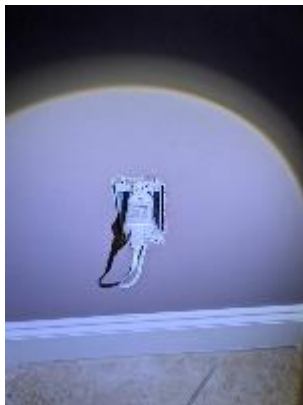
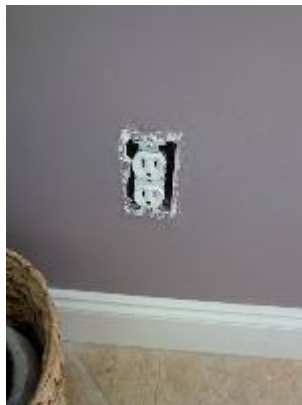
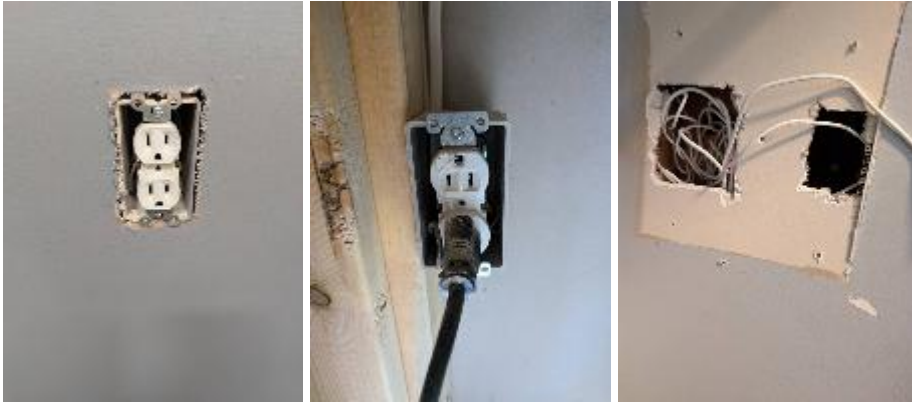
Cover plate is missing

Without a cover plate, can cause electrical shock if touched

Install a cover

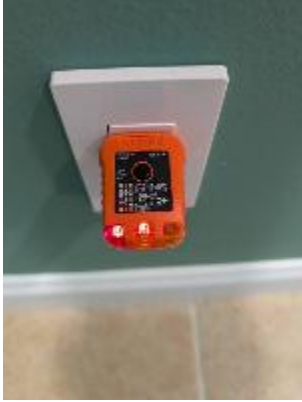
Tester shows hot neutral reverse

A hot neutral reverse outlet can cause electrical shock or damage an appliance

Have repaired by qualified electrician

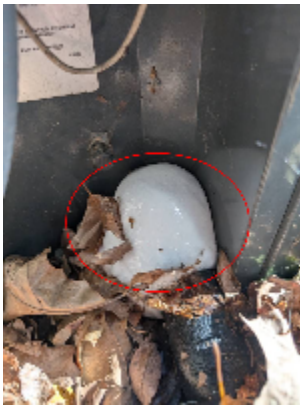
Could cause problems with AC Condenser

Ice on suction line

Recommend further evaluation and/or repair by qualified HVAC contractor.

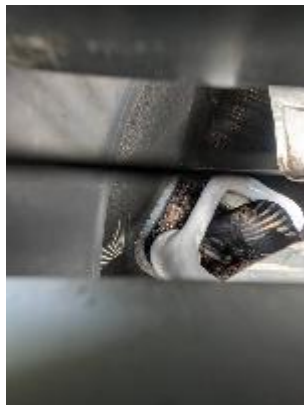
Ice on suction line

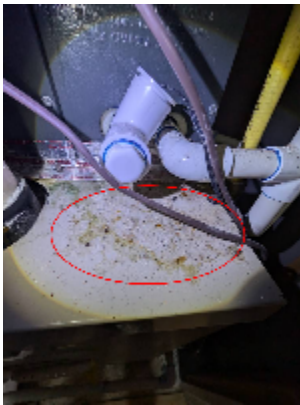
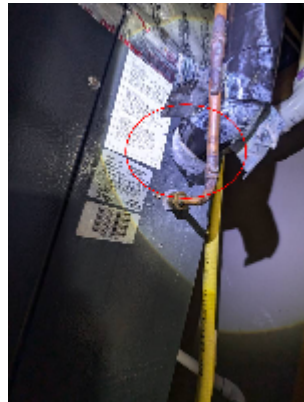
Ice forming at suction line and leaking on to furnace below.

Water dripping here from melting ice

Recommend further evaluation and/or repair by qualified HVAC contractor.

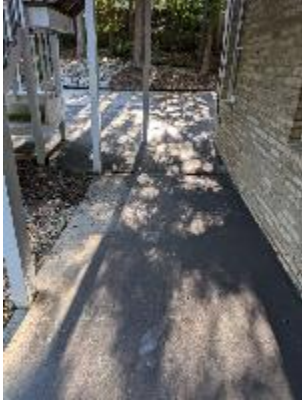
Directing more moisture towards the foundation increases the risk of moisture intrusion

Water should be directed away from all standing foundations to prevent potential water intrusion. The drainage strategy of the foundation is important. Expansive soils can be very destructive to the foundation if the moisture content of the perimeter varies.

Monitor the area for moisture buildup. Should it arise, if possible, regrading the area to achieve a slope away from the home. If regrading is not possible, add drain tile to re-direct water away from the home. Also, consult with a licensed waterproofing contractor to assess the situation and consider additional solutions such as waterproofing membranes or a sump pump installation to effectively manage water and protect the home's foundation and structure from potential water damage.

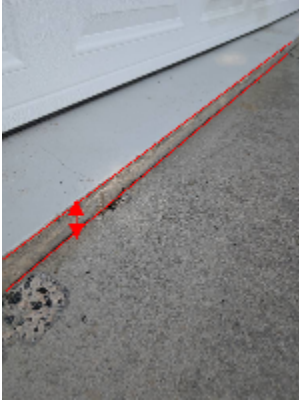
Further settlement can cause a larger gap between driveway and garage floor.

Recommend further evaluation and/or repair by qualified

concrete contractor.

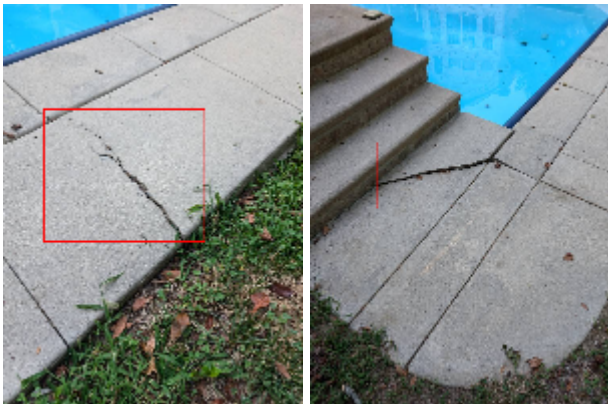
Settling with cracks creating a trip hazard.

The cracking has create an uneven surface increasing the potential for a pedestrian to trip

Cracks creating a discontinuity over 1/4 inch can trip many pedestrians

Replace either the damaged portion or entire section of patio depending on your aesthetic preference

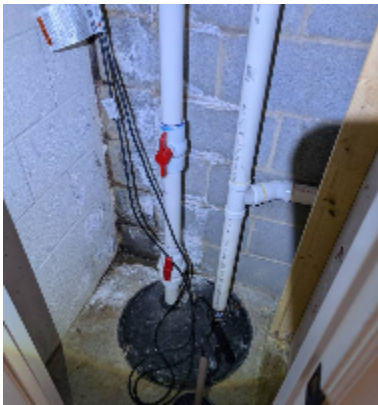
A pump that is running continuously could damage the pump.

Recommend further evaluation by a qualified plumbing contractor.

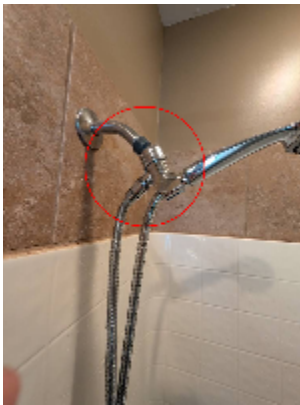
Shower head is leaking at the connection to the shower head stem

The leak may become a nuisance

Remove the shower head and reinstall with plumbers putty or nylon tape

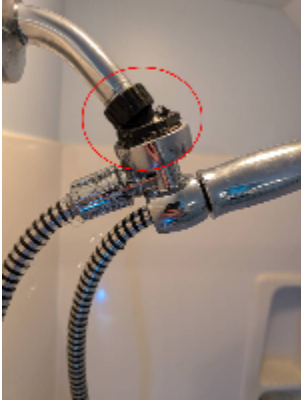
Shower head is leaking at the swivel ball

Replace the shower head

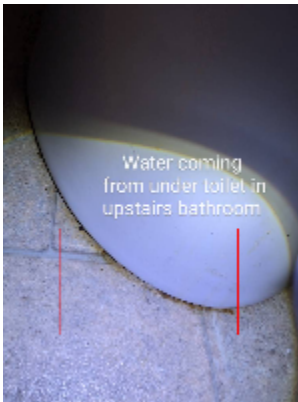
Leaking from the bowl at the time of the inspection

The leak may cause moisture damage to surrounding material

First, attempt to tighten all nuts. If that does not resolve the leaking, have a plumber evaluate the unit for repairs.

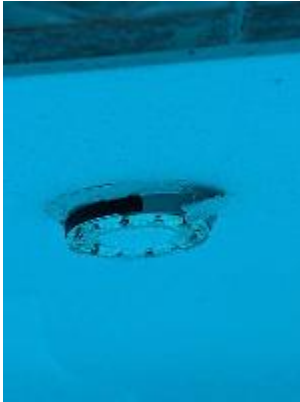
Caulk missing and coming off. Water inside light.

Recommend further evaluation and/or repair by a qualified pool contractor.

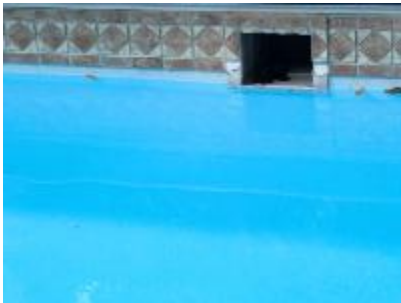
Low water level could indicate a leak. Recommend further evaluation and/or repair by qualified pool contractor. Recommend further evaluation of entire pool system.
