INSPECTION REPORT

1156 Windsor
Drive,
Kannapolis,
North Carolina
28081

Aug 21, 2024

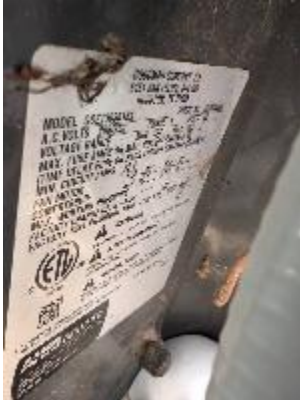
Condenser bottom is filled with debris

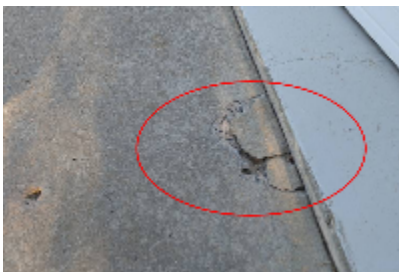
A popout is a conical fragment that breaks out of the surface of the concrete leaving a hole that may vary in size

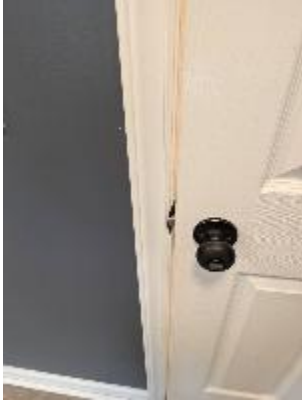
Without a working latch, the door will not close or lock effectively
